Periodical preventative
maintenance

Reflex Shower-toiletochair

51005600 (Standard)

51005605 (With 2 removable Leg/foot supports)

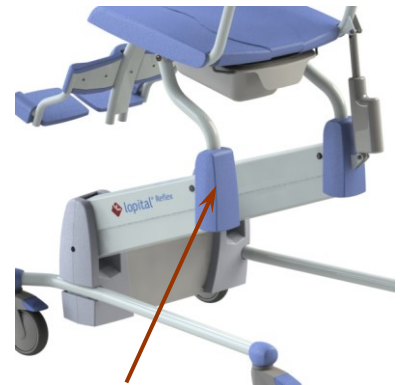
Figure 1 Chair supports

- Chairs before production year 2005 has to be checked extra good at corrosion on the seat carriers (under the PUR) and corrosion on the chassis (especially between the square turrets where the batteries are, don't remove the caps). (See figure 1 and 2). Remove the actuator cap.

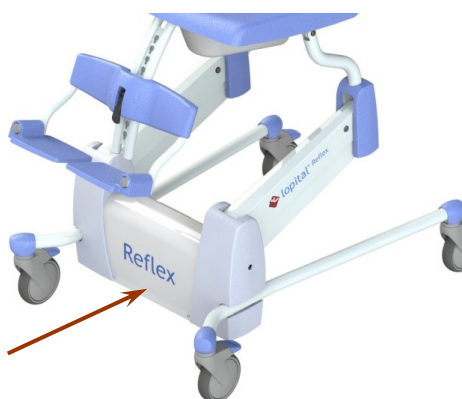
Figure 3 Cap

1. Put the chair in a high position. Unscrew screws (4x) and lift cover. (See figure 3)

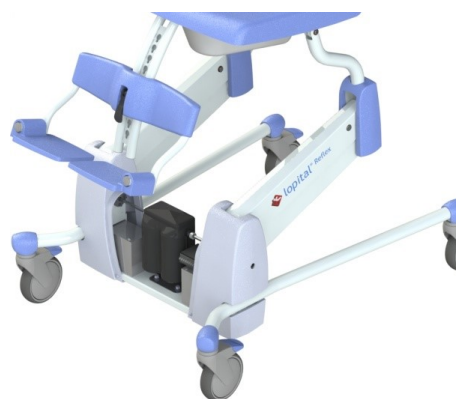
Figure 4 Batteries

2. Disconnect battery cables (the red plus pole first)

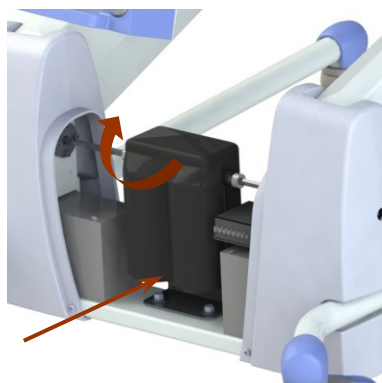
Figure 5 Motor

3. Detach M6 bolts under the motors. Tilt the motors. (See figure 5)

4. Replace batteries. Write the replacement date on the battery. Tilt the motor back and refasten the M6 bolt.

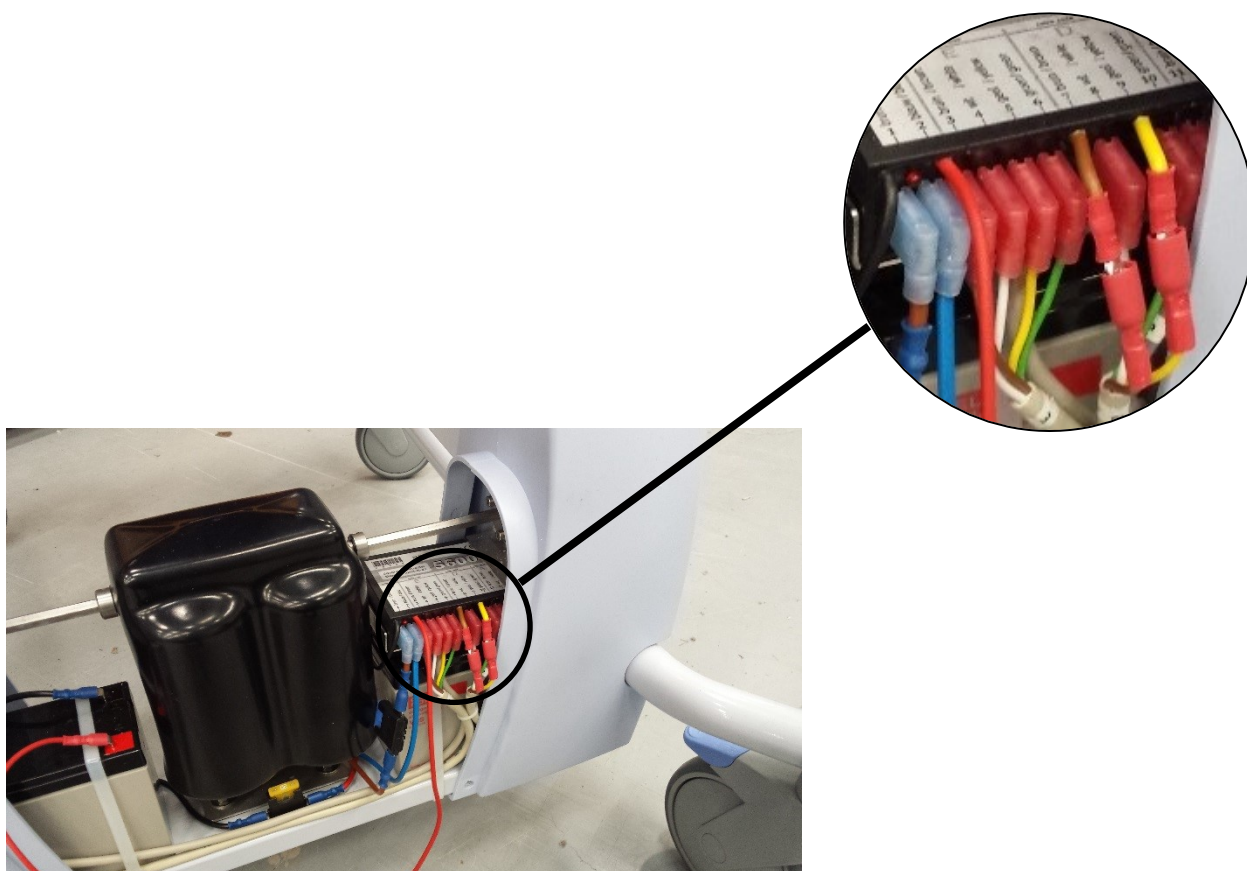
New version: from Serial number 5600.15.202
Serial number 5605.15.062

The controlbox has changed. It is not necessary to clean the controlbox every year.

On the picture below you can see the new situation.

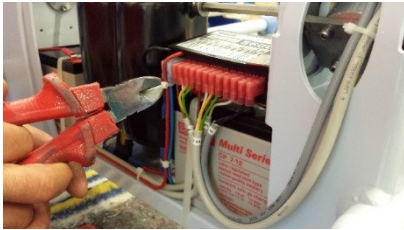
Figure 6 Control

1. Cut the tyraps of the cables so that the cables are disconnected. Please note that the battery cables are not connected, the controller is energized.

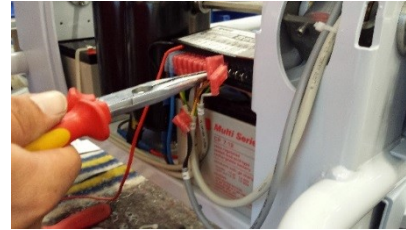
Figure 7 Disassemble plugs

2. Remove the plugs of the controller.

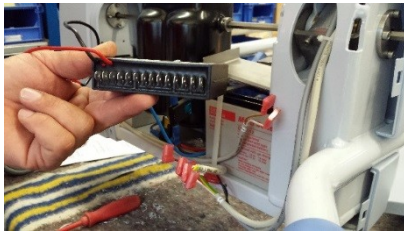
Figure 8 Disassemble the control

3. Disassemble the control.

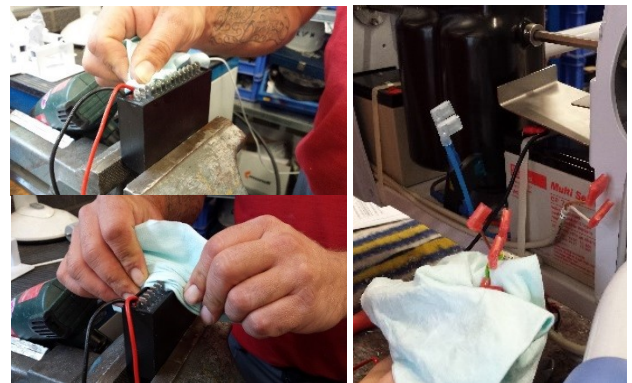
Figure 9 Cleaning control+ casing connectors

4. Clean the control well with Electrical cleaner, both the terminals and the bottom. Also clean the casing of the connectors

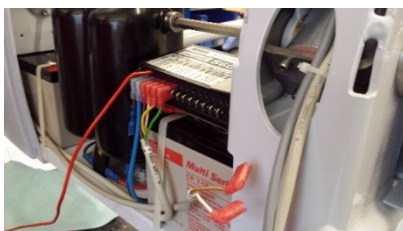
Figure 10 Connect control

5. Place the control back and connect the cables. Pay attention to the coding of the cables (M.E.D.A.B.). Squeeze the shells of the connectors firmly with pliers.

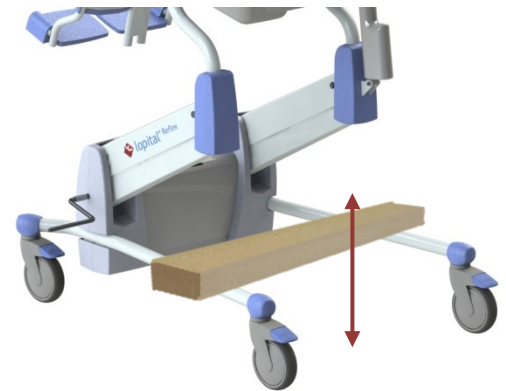
Figure 15

- Put the chair on the brake.
- Block the downward movement of the chair by putting something (e.g. a beam) between the floor and the support beam/scissor mechanism, and check whether the chair switches itself off (you should hear a "click").
- Ensure that the downward movement stops.
- Check the left and right section of the scissor mechanism separately.

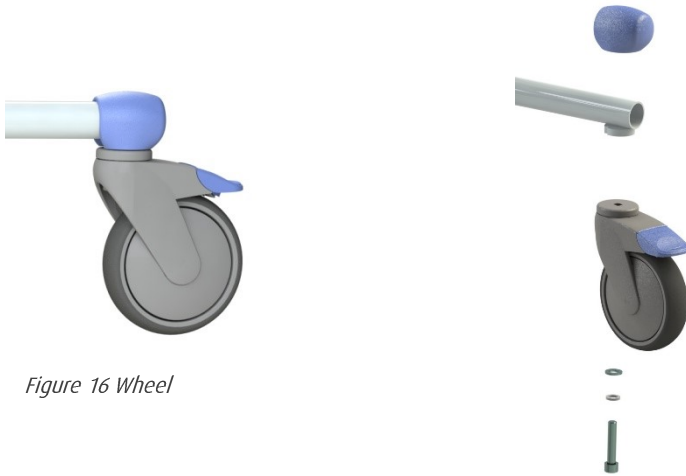
Figure 16 Wheel

- Check the attachment of the wheel (Tolerance)
- Check freewheel function + brakes.
- Do all four the wheels touch the floor on a flat surface? If not, check the chair right course.
- Brake lip intact?
- Check the tread.

Replace the wheels if they are damaged or worn.

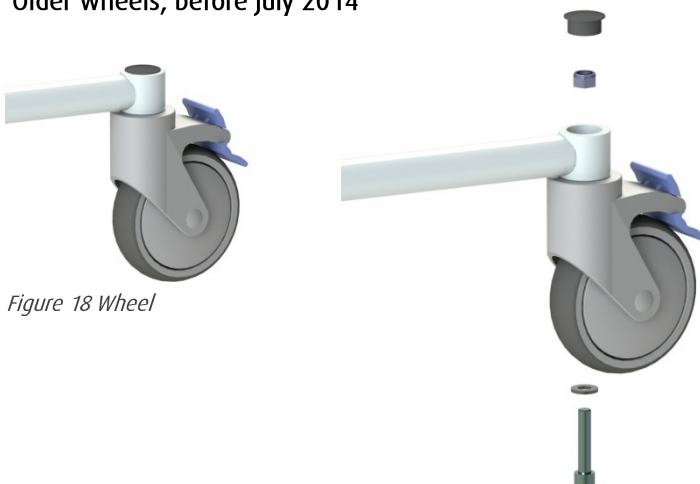
Figure 18 Wheel

- Check the attachment of the wheel (Tolerance)
- Check freewheel function + brakes.
- Do all four the wheels touch the floor on a flat surface? If not, check the chair right course.
- Brake lip intact?
- Check the tread.

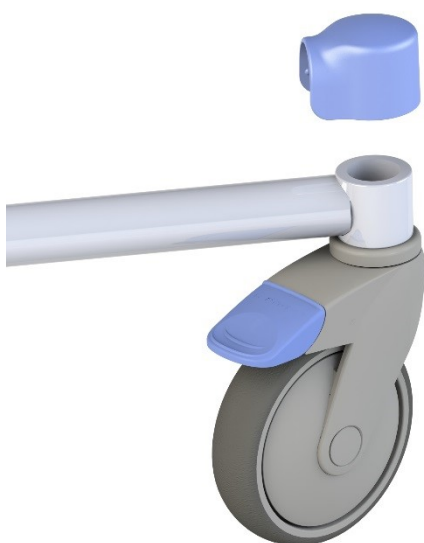
Figure 20 Cover

Chairs that are made before July 2014 are equipped with steel wheel clots. For those clots we have a cover to protect against damage.

Place the cover on the steel wheel clots, if it is not done already.

- Remove the decorative plug
- Is there corrosion on the wheel clots?
- Remove loose corrosion with a wirebrush.
- Treat the wheel clots with rust converter Noverox.
- Paint the wheel clots.
- Let the paint dry.
- Place the cover over the wheel clots.

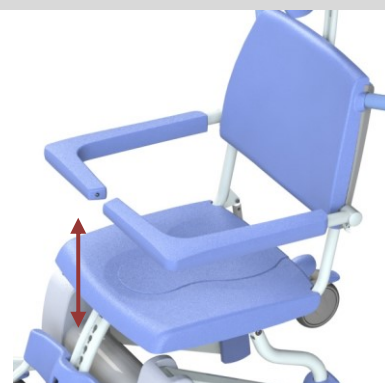
Figure 21 Armrest

- Inspect its functioning, and check for any damage, corrosion.
- Check its room for motion, measured at the front point (replace if it is more than 4 cm.) (See figure 21).
- Always treat corrosion.
- Are the arm supports evenly positioned?
- Slide PUR back if necessary.
- **The stainless-steel (A2) bolts and M8x16 DIN912 quality 12.9. should always be replaced by a Super Duplex 4529 bolt M8x16 (Order this bolt by Lopital B.V. Art.no. 75005640)**
- Clean and grease the hinge when the bolt is removed.
- Fastly secure bolts. (See figure 22)

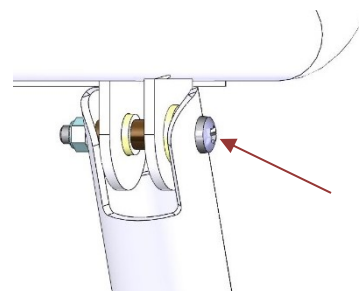
Figure 23 Bolt chair support

Replace M5 bolts once every other year (at the top of chair support). (See figure 23)

If the holes in the chair support have been worn away to an extreme level, replace the bolts by brass tilting levers.

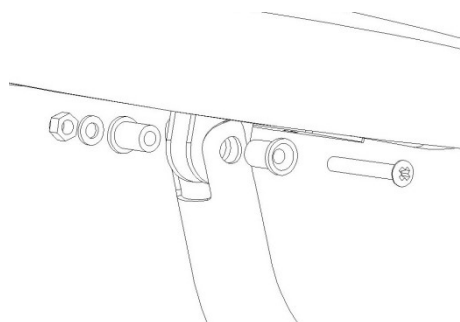
Figure 24 Mounting chair support

1. Unscrew the bolt and remove all the bearings, including those from the chair frame.

2. Drill the hole in the chair support to $\varnothing 11$.
PLEASE NOTE: a cable runs through the left chair support!
Remove all chips after drilling.
3. Fit the tilting bearings (70560028) into the chair support and the frame. Fit the bolt, washer and lock nut. M6x45 DIN966. Check whether the chair tilts smoothly.

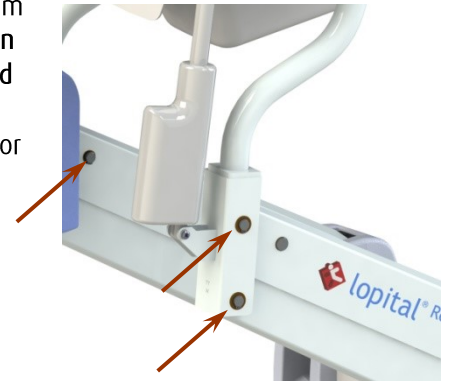
Figure 25 Axis, retaining rings en plastic bushes

Chairs from serial number RFL080501099 have a chair support fitted with an axle and plastic sleeves.

- Check whether the scissor mechanism and main levers leave any room for motion. Room for motion may occur on the left in particular. **When there is excessive room for motion, the part causing that room should be replaced.**
- This is necessary in order to maintain the structural quality. Whether or not there is excessive room for motion should be assessed by the mechanic.
- Check retaining rings (10 in total).

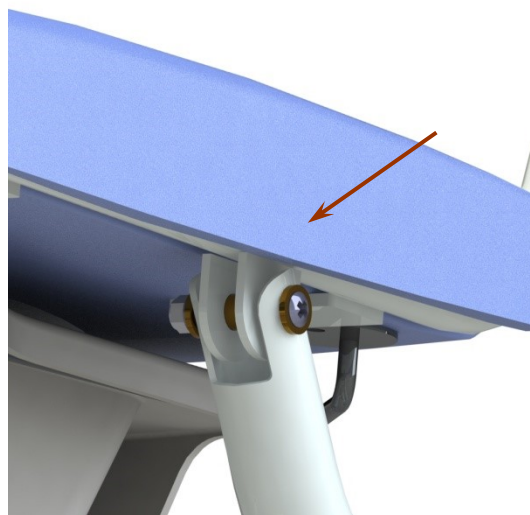
Figure 26 Hinge point

Endurance tests shows us that in the hinge point where the seat carrier and the seat frame are connected to each other, the brass bearing begin to show a groove wear after some time.

Therefore, this should be checked and lubricated bearing every year, and are **replaced every three years** to ensure the safety and quality.

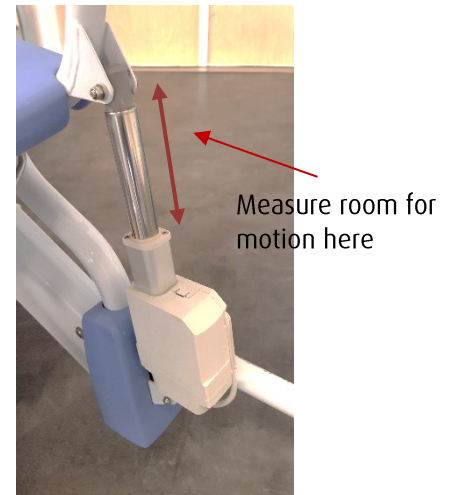
Figure 27 Room for motion

Room for motion more than 5 mm: replace actuator. Don't test in top position (*See figure 27*)

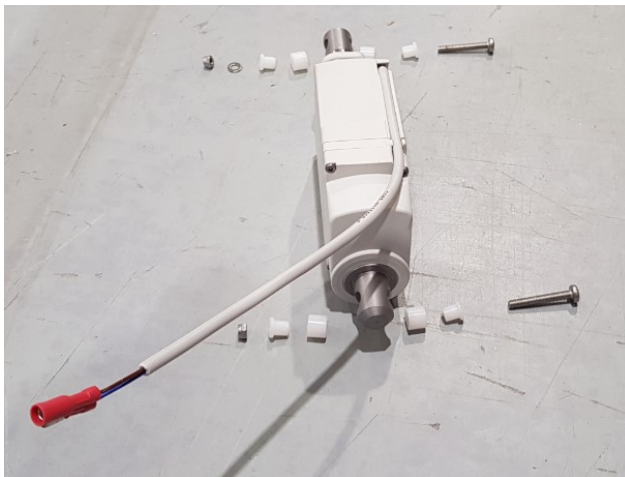
Figure 28 Tilt actuator

- Cut tiwrap.
- Unscrew screws.
- Detach plastic bearings.
- Detach actuator (NB: cable).
- Fit new actuator.
- Fit sleeve bearings.
- Tighten screws.
- Fit new tiwrap.
- Test tilting function.

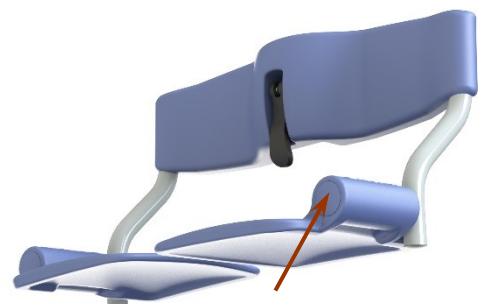
Figure 29 Foot rest

- Check for any damage.
- Fold up foot plates (should be stiff and stay upright). (They should remain in the folded position, without falling back automatically)
- Are the foot plates evenly fitted and slanting upwards a little towards the middle?
- Is the leg support securely fastened at different heights? Try different heights.
- Is the tightening handle present? (Art. No. 70560009).
- Is the footplate cap present?

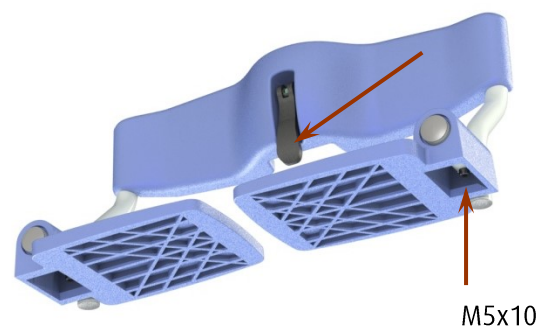
Figure 30 Older Foot rest

- Check for any damage.
- Fold up foot plates (should be stiff and stay upright). (They should remain in the folded position, without falling back automatically)
- Are the foot plates evenly fitted and slanting upwards a little towards the middle?
- Is the leg support securely fastened at different heights? Try different heights.
- Is the tightening handle present? (Art. No. 70560009).
- Since August 2009, the tightening handle has been replaced by a new, black, aluminium grip, without a cover.
- Check M5x10 (bottom of plate), and replace stainless-steel bolts with ELVZ 8.8 bolts. (See figure 30)
