Periodical preventative  
maintenance and inspection

Vienna deluxe wall & Vienna basic  
wall fixed height  
Dressing table

## Vienna deluxe wall 6500 5030

## Vienna basic wall Fixed height 65005035

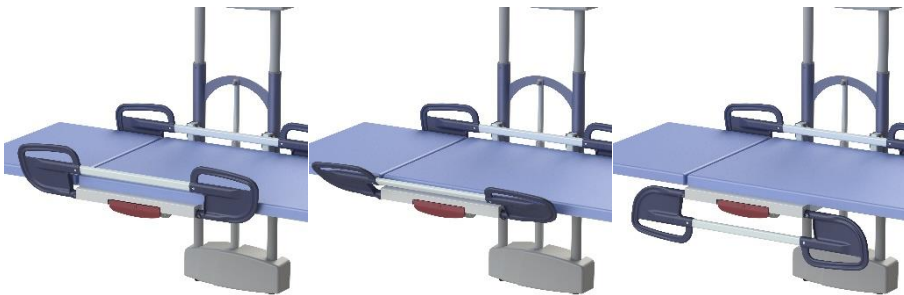
Figure 1 t/m 4 Side rail

- The side rail should rotate smoothly.
- They should be easy to lock and unlock.
- Lift the middle lying plate so that the side rail mechanism can be inspected.
- Check all bolts for fastening.
- The red handle should be undamaged.
- Lubricate the hinge (shaft), (preferably with Interflon fin super) after excess dirt has been removed.
- Lubricate the locking hook and the fork, (preferably with Interflon assembly grease).

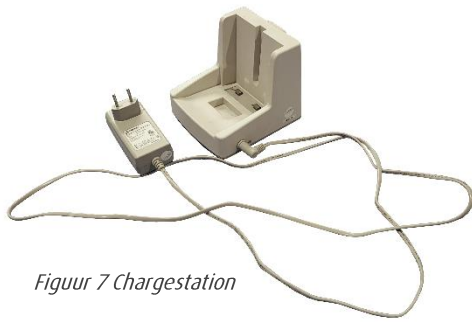
*Figuur 7 Chargestation*

- The charger must be tested each year in accordance with NEN 3140 and provided with an identification label and NEN 3140 label.
- Check charger for any damage (plug + cable + holder); if the cable is damaged, replace the whole charger.
- Check the charging voltage; it should be at least the value as indicated on the charger.
- Check whether there is too much corrosion on the connectors; also check the charger connector on the controlbox.
