Periodical preventative  
maintenance and inspection

Reflex Shower-toiletochair

Reflex Douche-Toilet stoel  
51005600

Reflex Douche-Toilet stoel  
51005605

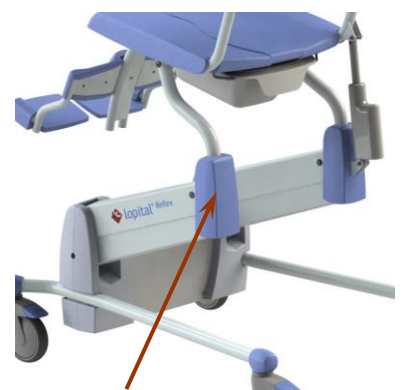
Figure 1 Chair supports

- Visually check all painted parts for damage and corrosion. Touch up if necessary.
- Chairs before production year 2005 has to be checked extra good at corrosion on the seat carriers (under the PUR) and corrosion on the chassis (especially between the square turrets where the batteries are, don't remove the caps). (See figure 1 and 2). Remove the actuator cap.

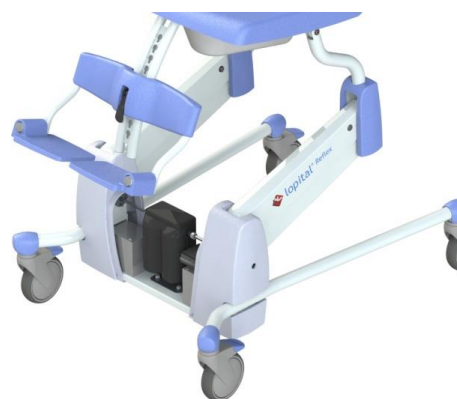
Figure 4 Batteries

2. Disconnect battery cables (the red plus pole first)

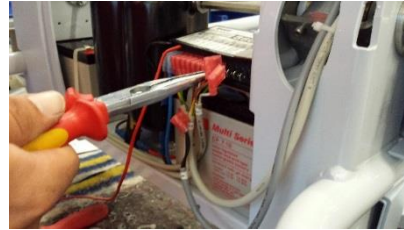
Figure 8 Disassemble plugs

2. Remove the plugs of the controller.

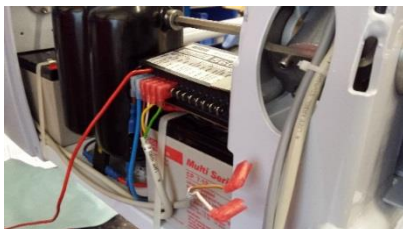
Figure 11 Connect control

5. Place the control back and connect the cables. Pay attention to the coding of the cables (M.E.D.A.B.). Squeeze the shells of the connectors firmly with pliers.

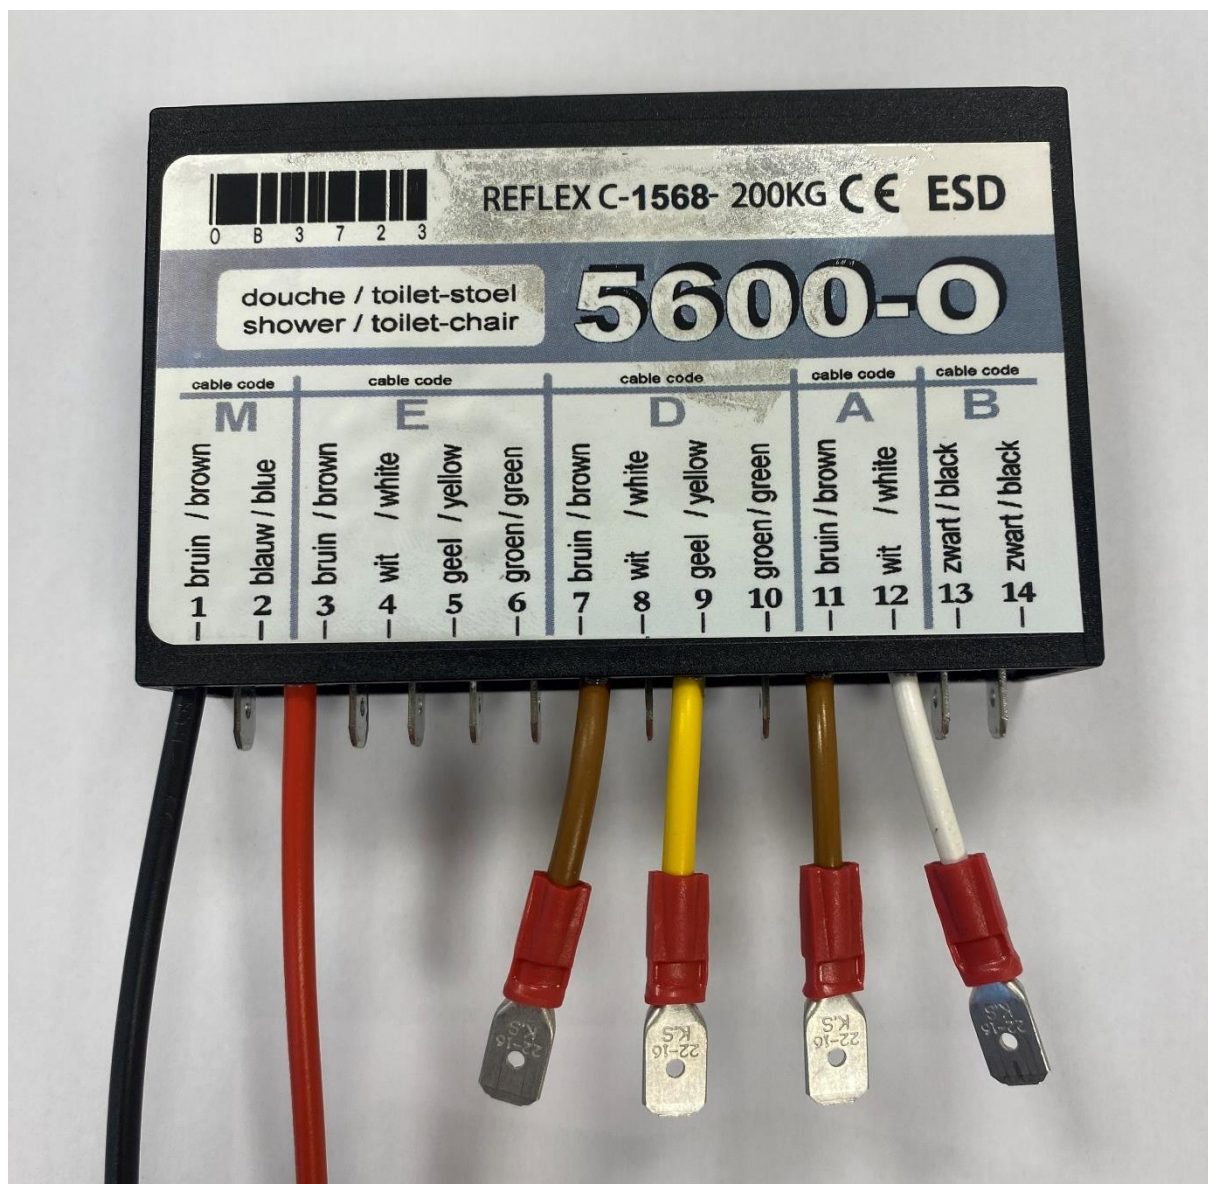
Figure 12 New control

New version: from Serial number 5600.22.218

Serial number 5605.22.174

These chairs are equipped with a control that also needs to be cleaned every year.

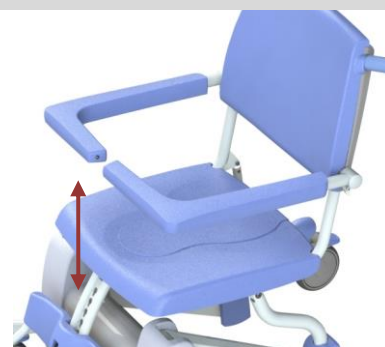
Figure 23 Armrest

- Inspect its functioning, and check for any damage, corrosion.
- Check its room for motion, measured at the front point (replace if it is more than 4 cm.) (See figure 23).
- Always treat corrosion.
- Are the arm supports evenly positioned?
- Slide PUR back if necessary.
- **The stainless-steel (A2) screws and M8x16 DIN912 quality 12.9. should always be replaced by a Super Duplex 4529 screw M8x16 (Order this screw by Lopital B.V. Art.no. 75005640)**
- Clean and grease the hinge when the screw is removed.
- Fastly secure screws. (See figure 22)
