Periodical preventative  
maintenance

Marina Shower trolley

61002300 (hydraulic, standard)  
61002305 (hydraulic, wide)  
61002305 (hydraulic, central braking)  
61002320 (hydraulic, short)  
61002330 (hydraulic, long)  
61002345 (hydraulic, wide and long)

61002350 (electric, standard)  
61002355 (electric, wide)  
61002360 (electric, central braking)  
61002370 (electric, short)  
61002380 (electric, long)  
61002385 (electric, wide and long)

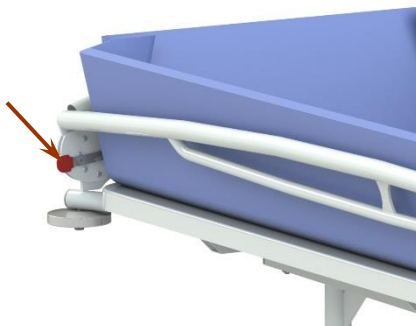
Figure 1 Side barriers lock

- Both side barriers should open and close smoothly.
- They should be easy to lock and unlock.
- Check whether all the bolts are present and tightly screwed.
- The black or red submersible cap should be undamaged.
- Lubricate the hinge between the two hinge plates (preferably with innotec ceramic grease) after removing any excess dirt and corrosion.

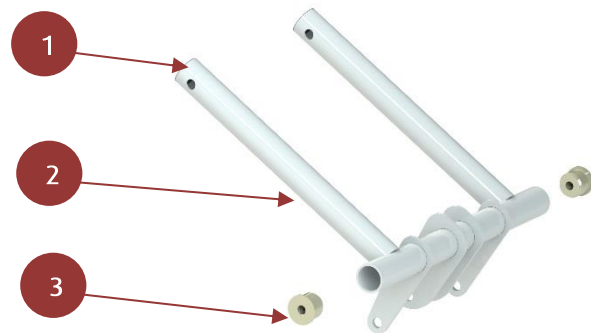
Figure 8 Lever

Check for any damage. If the lever is bent, it should be replaced. If it is from aluminium, it should be replaced as a precaution.

Check retaining rings (8 in total; they connect the subframe to the two levers).

1. Insert cap
2. Lever
3. Bearing

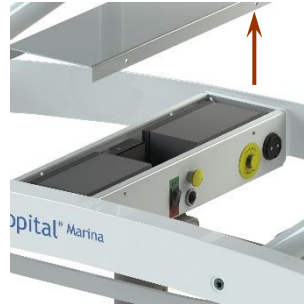
Figure 12 Cap removed

2. The cap can now be tilted up.

3. Replace batteries. Write the replacement date on the battery.  
Connect all the cables; the red positive pole should be connected last.  
Refit cap and secure.  
Test the shower trolley.
