Periodical preventative  
maintenance and inspection

## Elexo XXL Shower-Toilechair

51005300

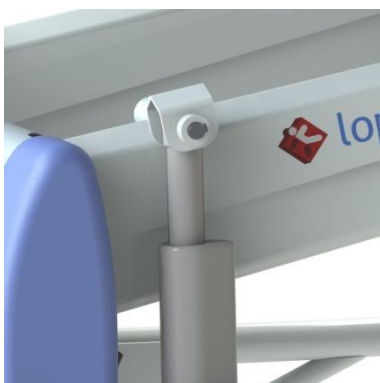
Figure 1 Screw actuator

- Visually check if all labels are present and legible.
  - o Serialnumberlabel:
    - Is the serial number still legible?
    - Is the datamatrix still readable for a scanner?
    - Is the CE logo still visible?
  - o Inspectionlabel:
    - Is the inspection date still legible?
  - o QR label:
    - Is the QR code still readable for a QR scanner?
- Visually check all painted parts for damage and corrosion. Touch up if necessary.
- Check PUR parts for severe discolouration (Brown in particular) and damage.
- Are all the screws present and securely fitted? Also that of the guide?
- Check whether the screws of the actuator are securely fitted, both at the top and at the bottom.  
(See figure 1 and 2)

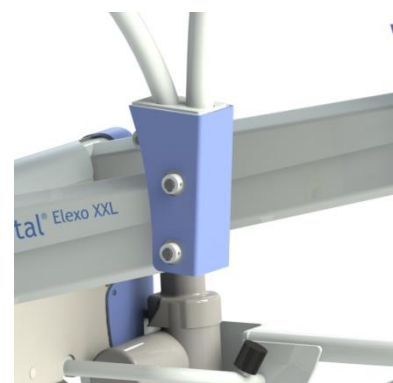
Figure 3 Retaining rings

- Motor cover still present and not torn?
- Check whether all the retaining rings are present (8 in total). If not present then it should be placed, otherwise rejected the chair. (See figure 3)
- Does the chair move up and down smoothly?

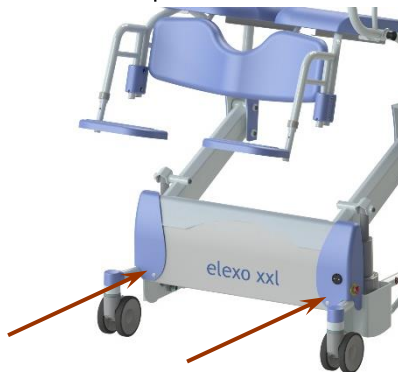
Figure 4 Cap front

1. Remove pressure nails at the front (2x).

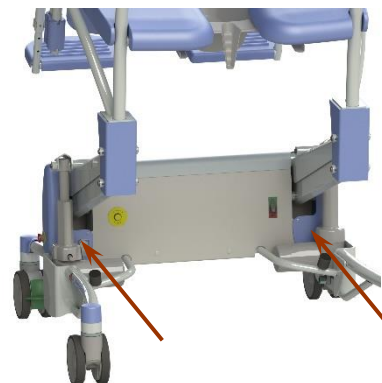
Figure 5 Cap Back

2. Unscrew screws at the back (2x) and detach end covers.

*Please note: the charger connector is attached to the cover.*

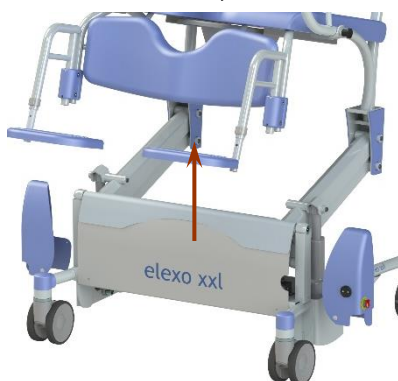
Figure 6 Battery cap

3. The front part of the battery cover can now be tilted up.

4. Replace batteries. Write the replacement date on the battery. Connect all the cables; the red positive pole should be connected last. Refit cap and secure. Test chair.

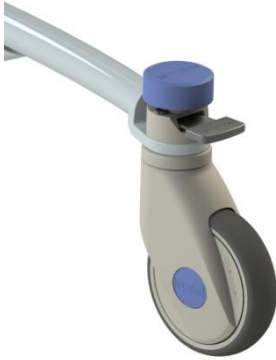
*Figure 14 Wheel*

Old version: Before serialnumber 5300.18.020

- Check the attachment of the wheel (Tolerance)
- Check freewheel function + brakes.
- Do all four the wheels touch the floor on a flat surface? If not, check the chair right course.
- Brake knob intact?
- Unlocking lip intact?
- Check the tread.

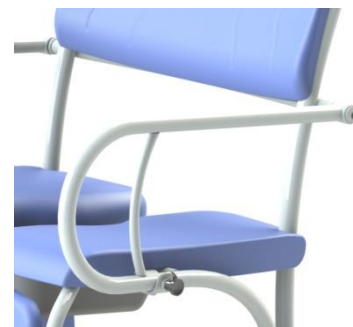
*Figure 16 Armrest*

- Inspect its functioning, and check for any damage, corrosion. Always treat corrosion.
- Check its room for motion, measured at the front point.
- Are the arm supports evenly positioned?

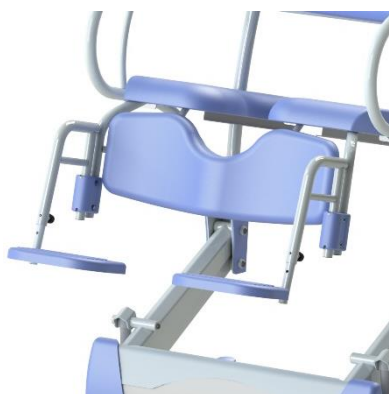
Figure 17 Footrest

**New version:** From serialnumber 5300.20.005

Chairs from this serial number are equipped with a height-adjustable footrest.

- Check for any damage.
- Are the foot plates evenly fitted and slanting upwards a little towards the middle?
- Check the height-adjustment, check for any damage.

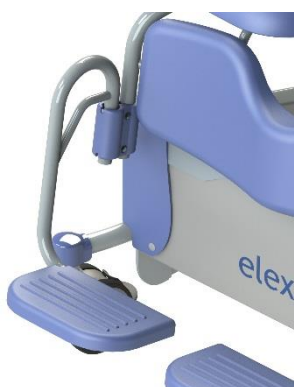
Figure 18 Footrest

- Check for any damage.
- Are the foot plates evenly fitted and slanting upwards a little towards the middle?
