Periodical preventative  
maintenance and inspection

Tango XXL Shower-toilechair

51005800

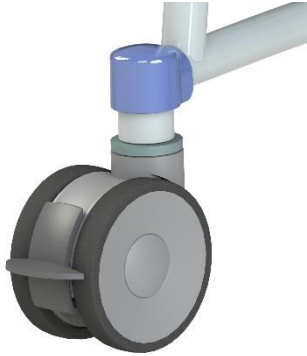
Figure 1 Wheel

New version: From serialnumber 5800.18.050

- Check the attachment of the wheel (Tolerance)
- Check freewheel function + brakes.
- Do all four the wheels touch the floor on a flat surface? If not, check the chair right course.
- Brake lip intact?
- Check the tread.

Replace the wheels if they are damaged or worn.

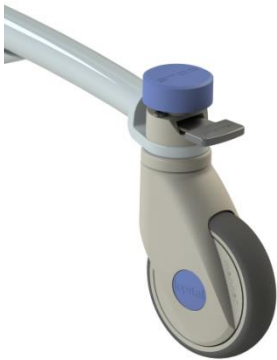
*Figure 3 Wheel*

Old version: Before serialnumber 5800.18.030

- Check the attachment of the wheel (Tolerance)
- Check freewheel function + brakes.
- Do all four the wheels touch the floor on a flat surface? If not, check the chair right course.
- Brake knob intact?
- Unlocking lip intact?
- Check the tread.

Replace the wheels if they are damaged or worn.

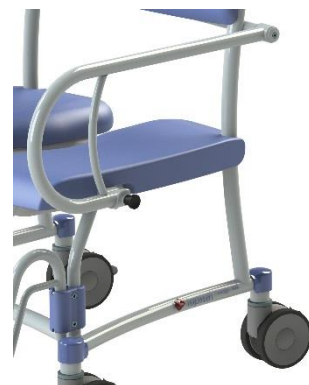
Figure 5 Armrest  
Required tools

- Inspect its functioning, and check for any damage, corrosion. Always treat corrosion. Check its room for motion, measured at the front point.
- Are the armrests evenly positioned?
- Fastly secure screws.

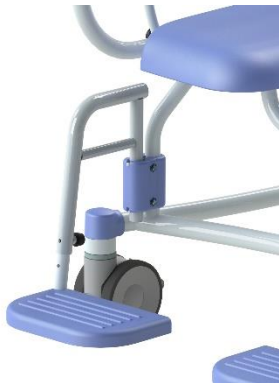
Figure 6 Footrest

**New version: From serialnumber 5800.20.007**

Chairs from this serial number are equipped with a height-adjustable footrest.

- Check for any damage.
- Are the foot plates evenly fitted and slanting upwards a little towards the middle?
- Check the height-adjustment, check for any damage.

It is strongly recommended to replace the footplates every 5 years, due to hygiene.

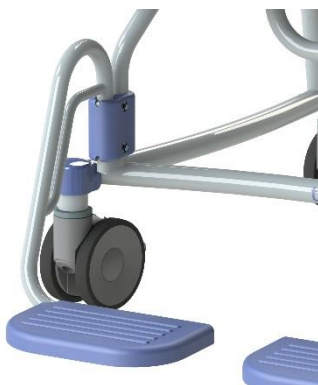
Figure 7 Footrest

**Older version: From serialnumber 5800.20.007**

- Check for any damage.
- Fold up foot plates (should be stiff and stay upright). (They should remain in the folded position, without falling back automatically)
- Are the foot plates evenly fitted and slanting upwards a little towards the middle?
