Maintenance protocol

**Tango XL & Tango XXL  
shower toilet chair**

MAIN5850-2026-01\_EN

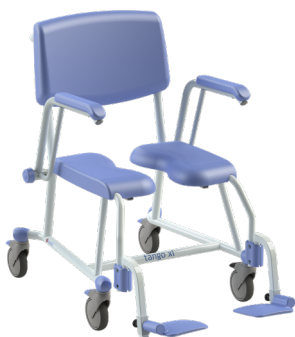
Tango XL shower toilet chair: 5100 5750

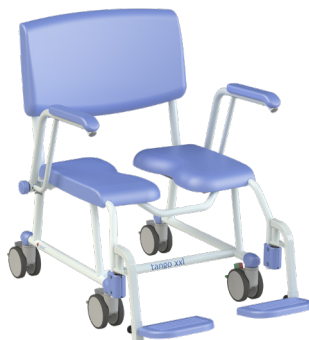
Tango XXL shower toilet chair: 5100 5850

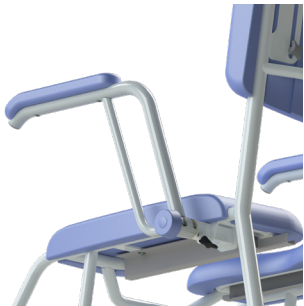
Figure 7 Tango XXL armrest

- Check the operation of the armrests.
- Check the armrest for damage, rust and clearance.
- Check that all screws are present and securely tightened.
- Check the width adjustment of the armrests on the Tango XXL.
