Periodical preventative maintenance and inspection

Elexo Shower-toiletchair

Elexo Shower-Toiletchair 51005500

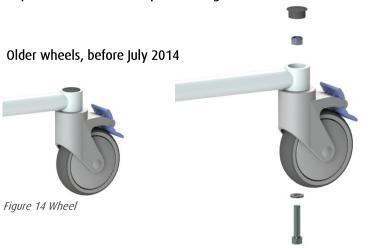
- Check the attachment of the wheel (Tolerance)
- Check freewheel function + brakes.
- Do all four the wheels touch the floor on a flat surface? If not, check the chair right course.
- Brake lip intact?
- Check the tread.

Replace the wheels if they are damaged or worn.

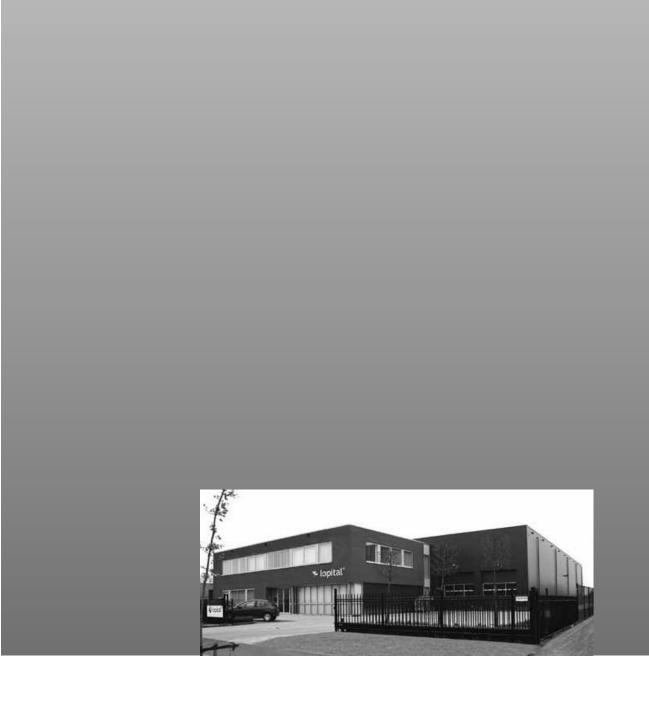
For questions about the maintenance protocol, contact Lopital (telephone +31 (0)13 5239300 or mail info@lopital.nl). You will need the serial number (outlined in red) to inform Lopital. See the serial number label on the product for this number.
